Replaced clip-on plug and crimp-on wire connectors on the front passenger-side fender mounted turn indicator.

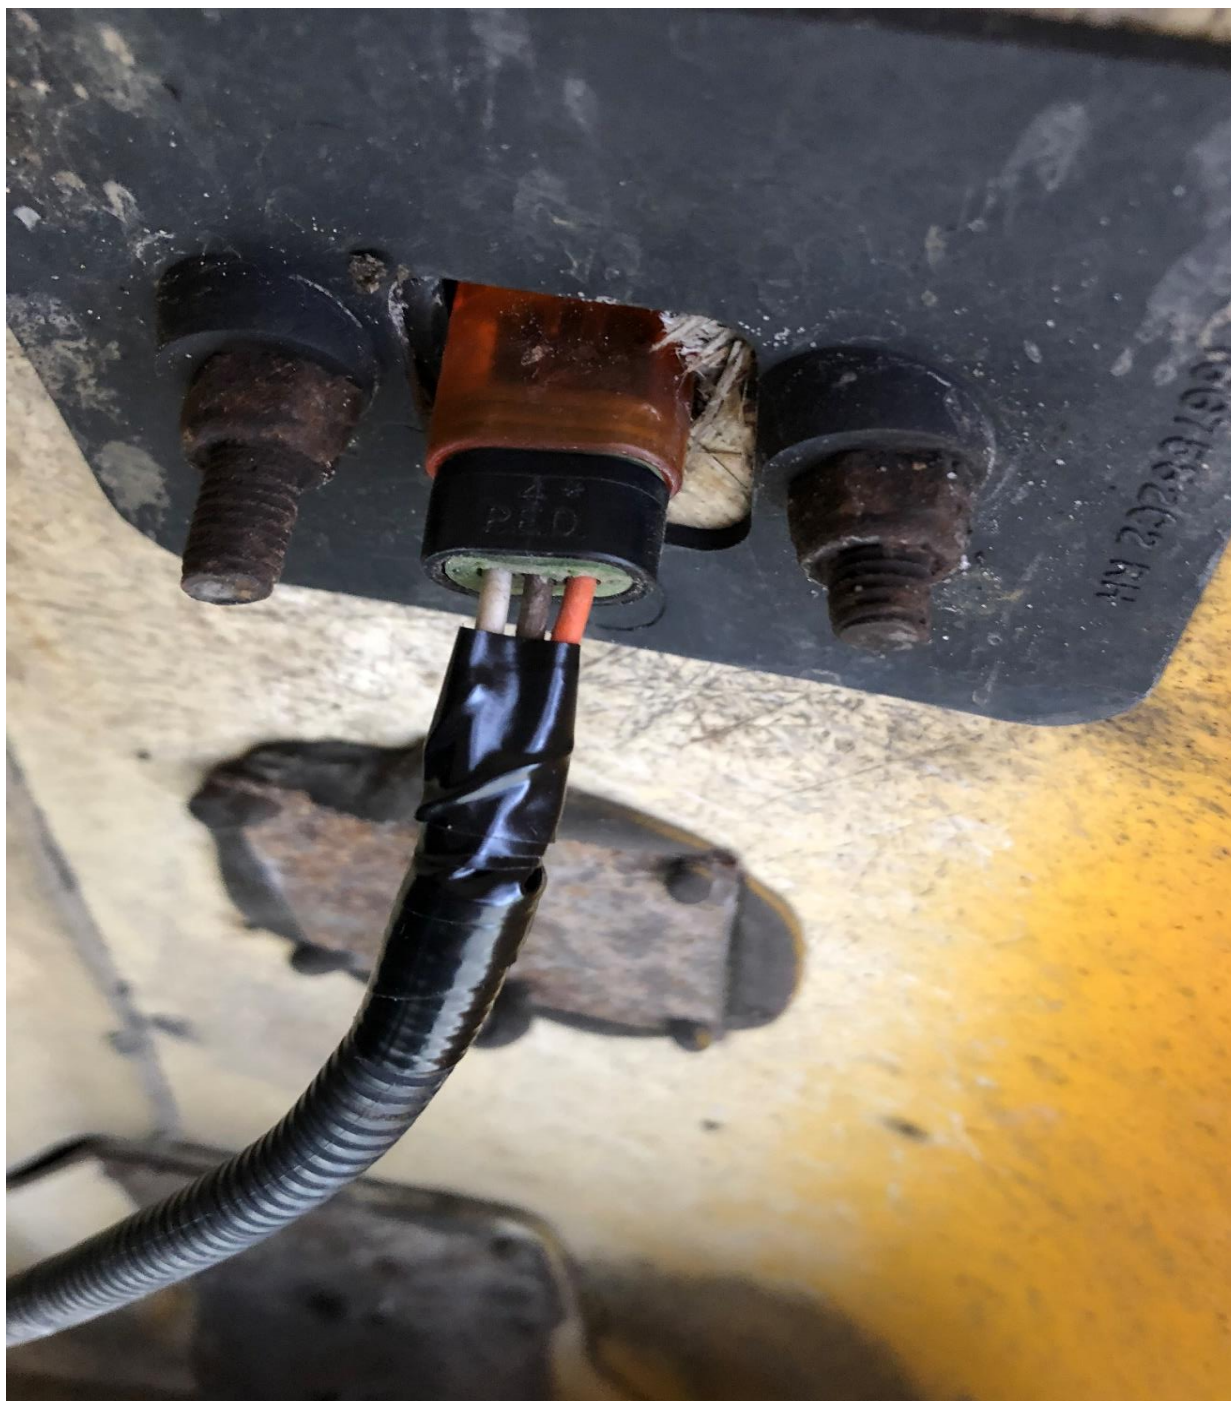
Connectors are all flush within the plug, and withstood a tug test.
Plug snapped into place with little effort indicating proper alignment.
No indication of crimp-on connectors shifting backward.

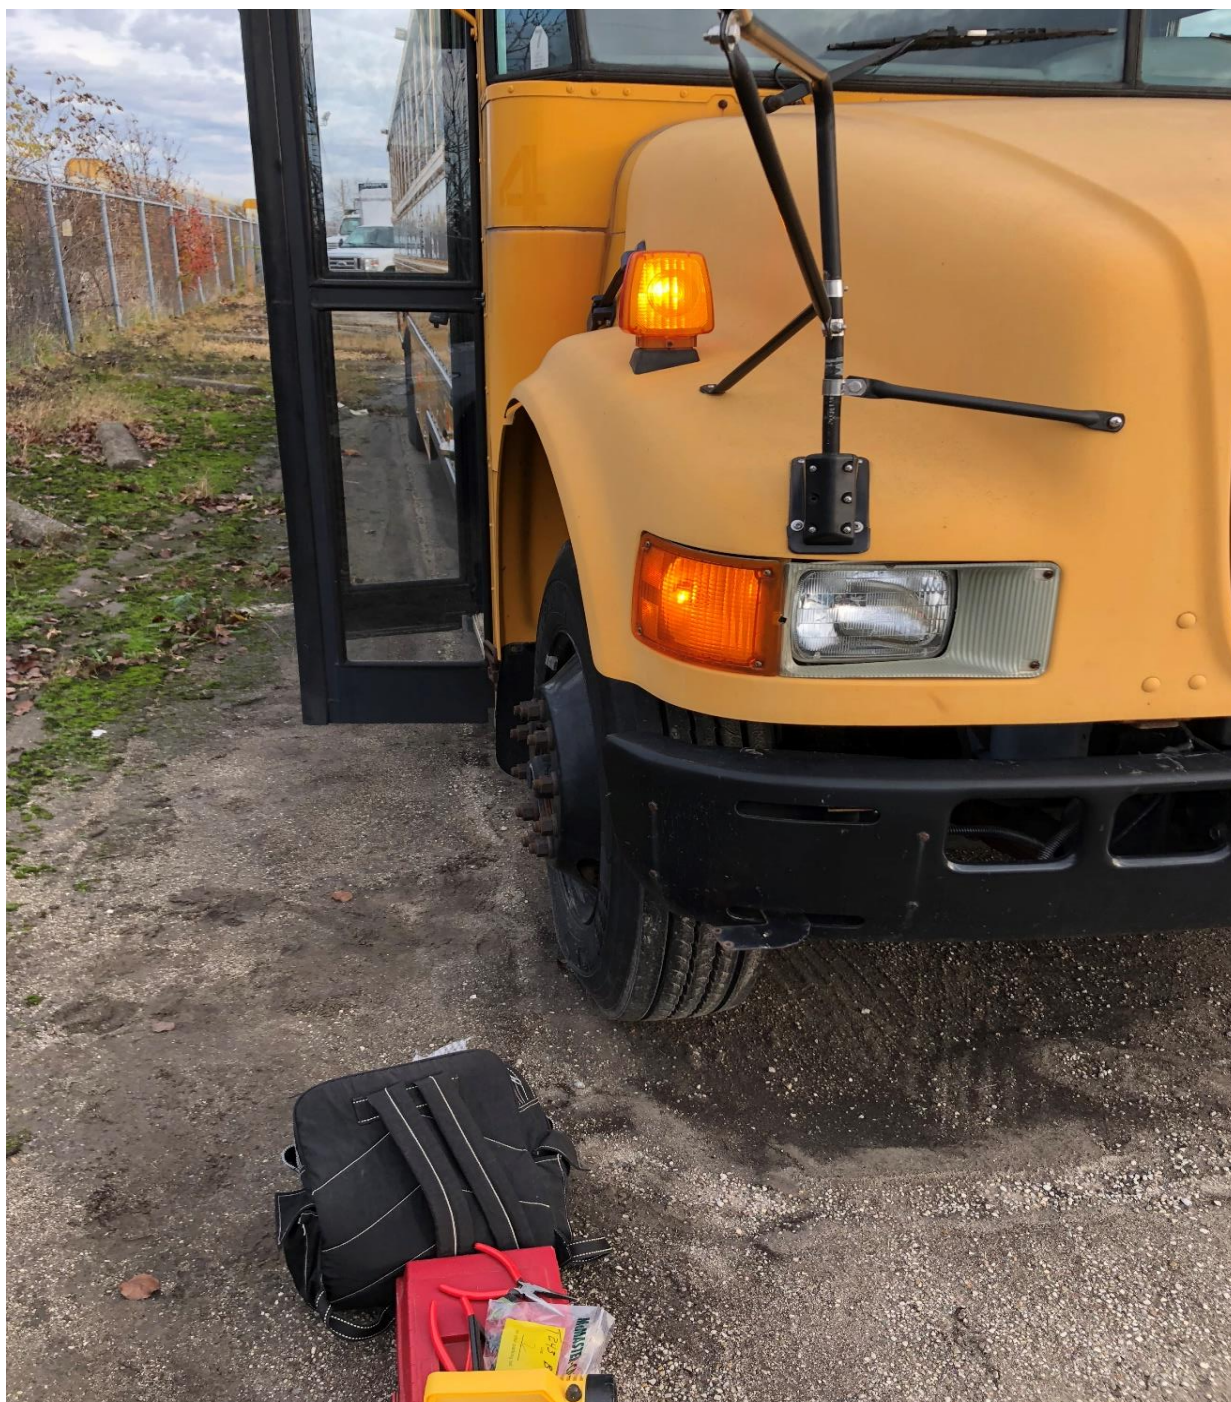
Turn indicator works after replacement.
Wire harness was tugged and wiggled with no adverse affect to turn indicator operation.
