3/8/2020: There appears to be only one windshield upper defog fan, mounted along windshield centerline. Only one fan switch exists (labeled LEFT FAN) but this may be a retrofit as the right fan hole has a blanking plate. ?? Front and back of switch are shown.

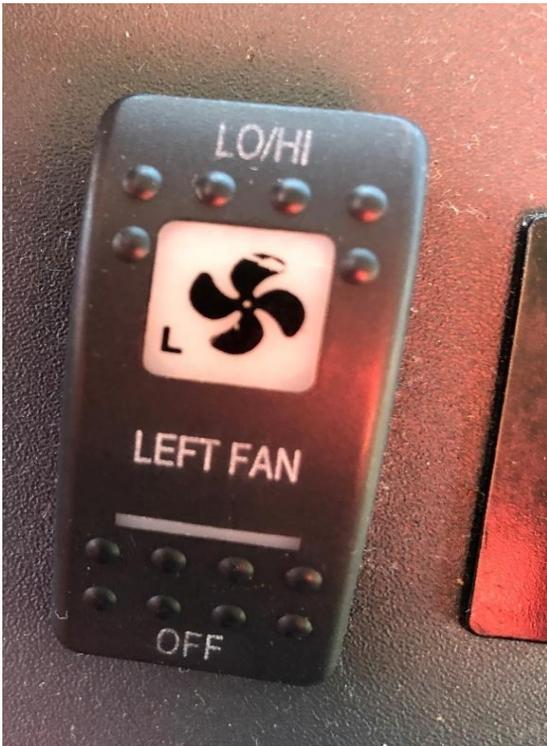
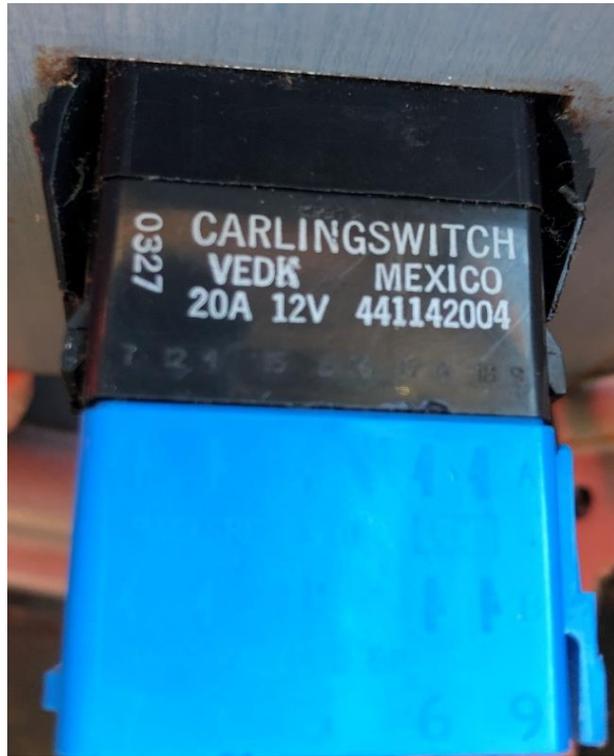
This switch showed erratic response.

Sometimes the fan would run with switch in LO or HI position, but not both in the same OFF/LO/HI/LO/OFF cycling of the switch.

The fan did not respond to the switch most of the time.

12VDC was consistently available at the back side of the connector block.

Switch date code seems to indicate 27th week of 2003. They do wear out.

I recommend replacing the switch. I'll check price & availability.

3/28/2020: UHL's crossreferenced a direct replacement switch: International # 6131248C1. Replaced existing failed switch. Removable terminal block was not altered. Mounting plate and switch were returned to operating position on dash. Fan responded properly and reliably through six OFF/LO/HI/LO/OFF cyclings of the switch.

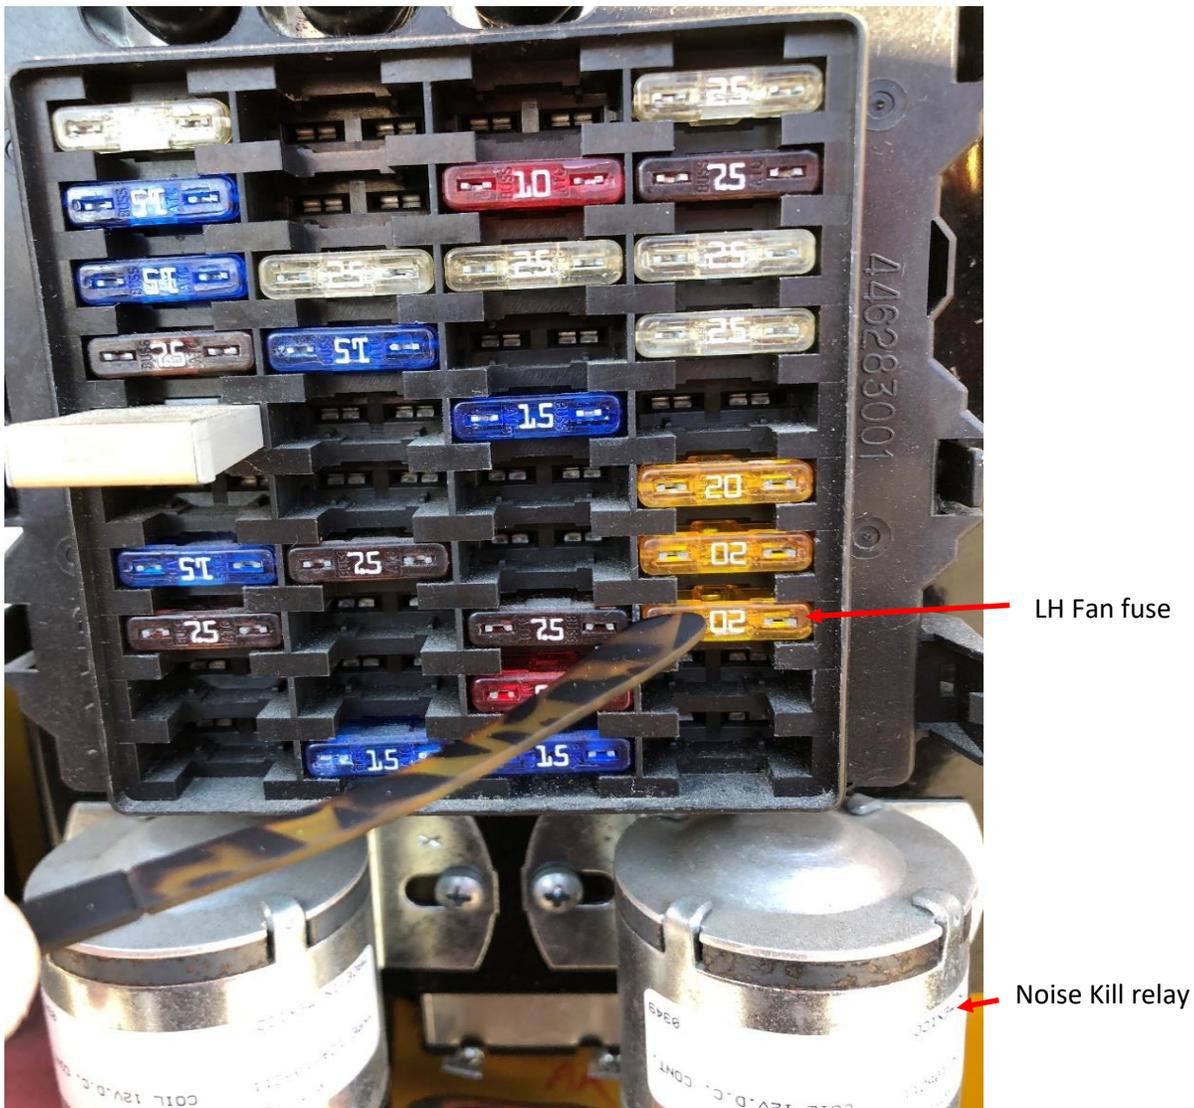
Fuse #38 listed as LH DEFOG FAN, 7.5A. Actual device is 20A.  
 According to fuse block schedule there should be separate 7.5A fuses for two defog fans.  
 12VDC power constantly available at fuse #38 with NOISE KILL switch ON.
