3/8/2020: There appears to be only one windshield upper defog fan, mounted along windshield centerline. Only one fan switch exists (labeled LEFT FAN) but this may be a retrofit as the right fan hole has a blanking plate. ?? Front and back of switch are shown.

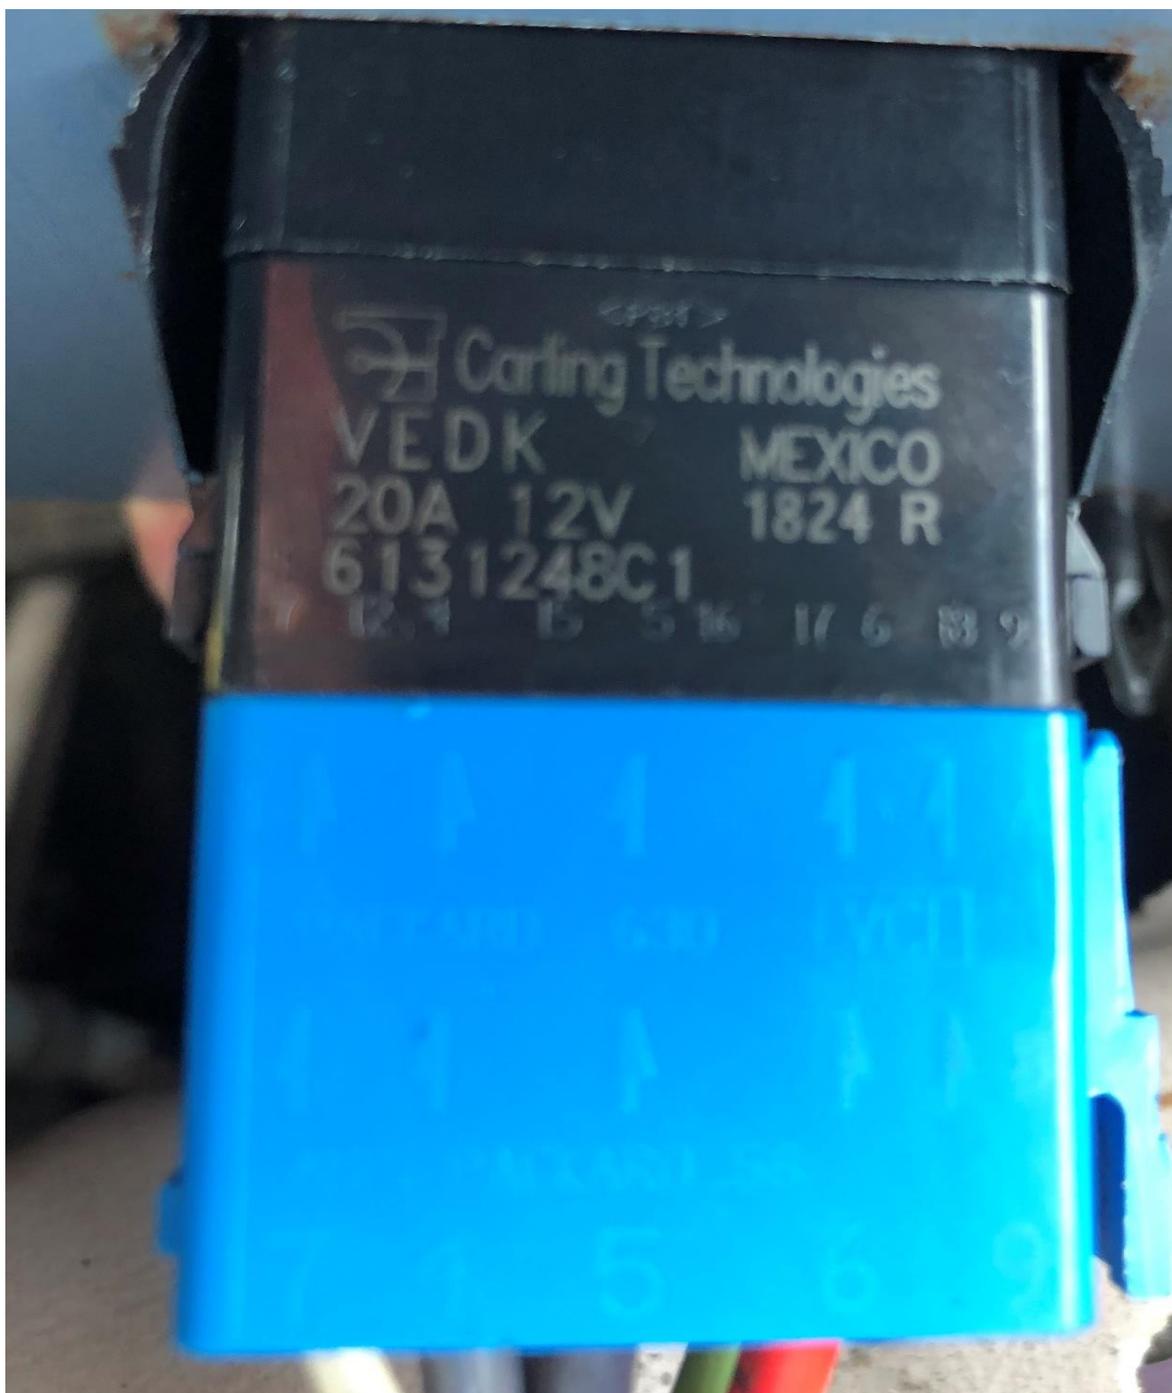
Fuse #38 listed as LH DEFOG FAN, 7.5A. Actual device is 20A.  
 According to fuse block schedule there should be separate 7.5A fuses for two defog fans.  
 12VDC power constantly available at fuse #38 with NOISE KILL switch ON.

3/28/2020: UHL's crossreferenced a direct replacement switch: International # 6131248C1. Replaced existing failed switch. Removable terminal block was not altered. Mounting plate and switch were returned to operating position on dash. Fan responded properly and reliably through six OFF/LO/HI/LO/OFF cyclings of the switch.
